APPENDIX B
Pre-Test Inspections
8/31/11 – 9/1/11

T/S STATE OF MICHIGAN

Pre-Test Inspection

Caterpillar Pre-test Worklist

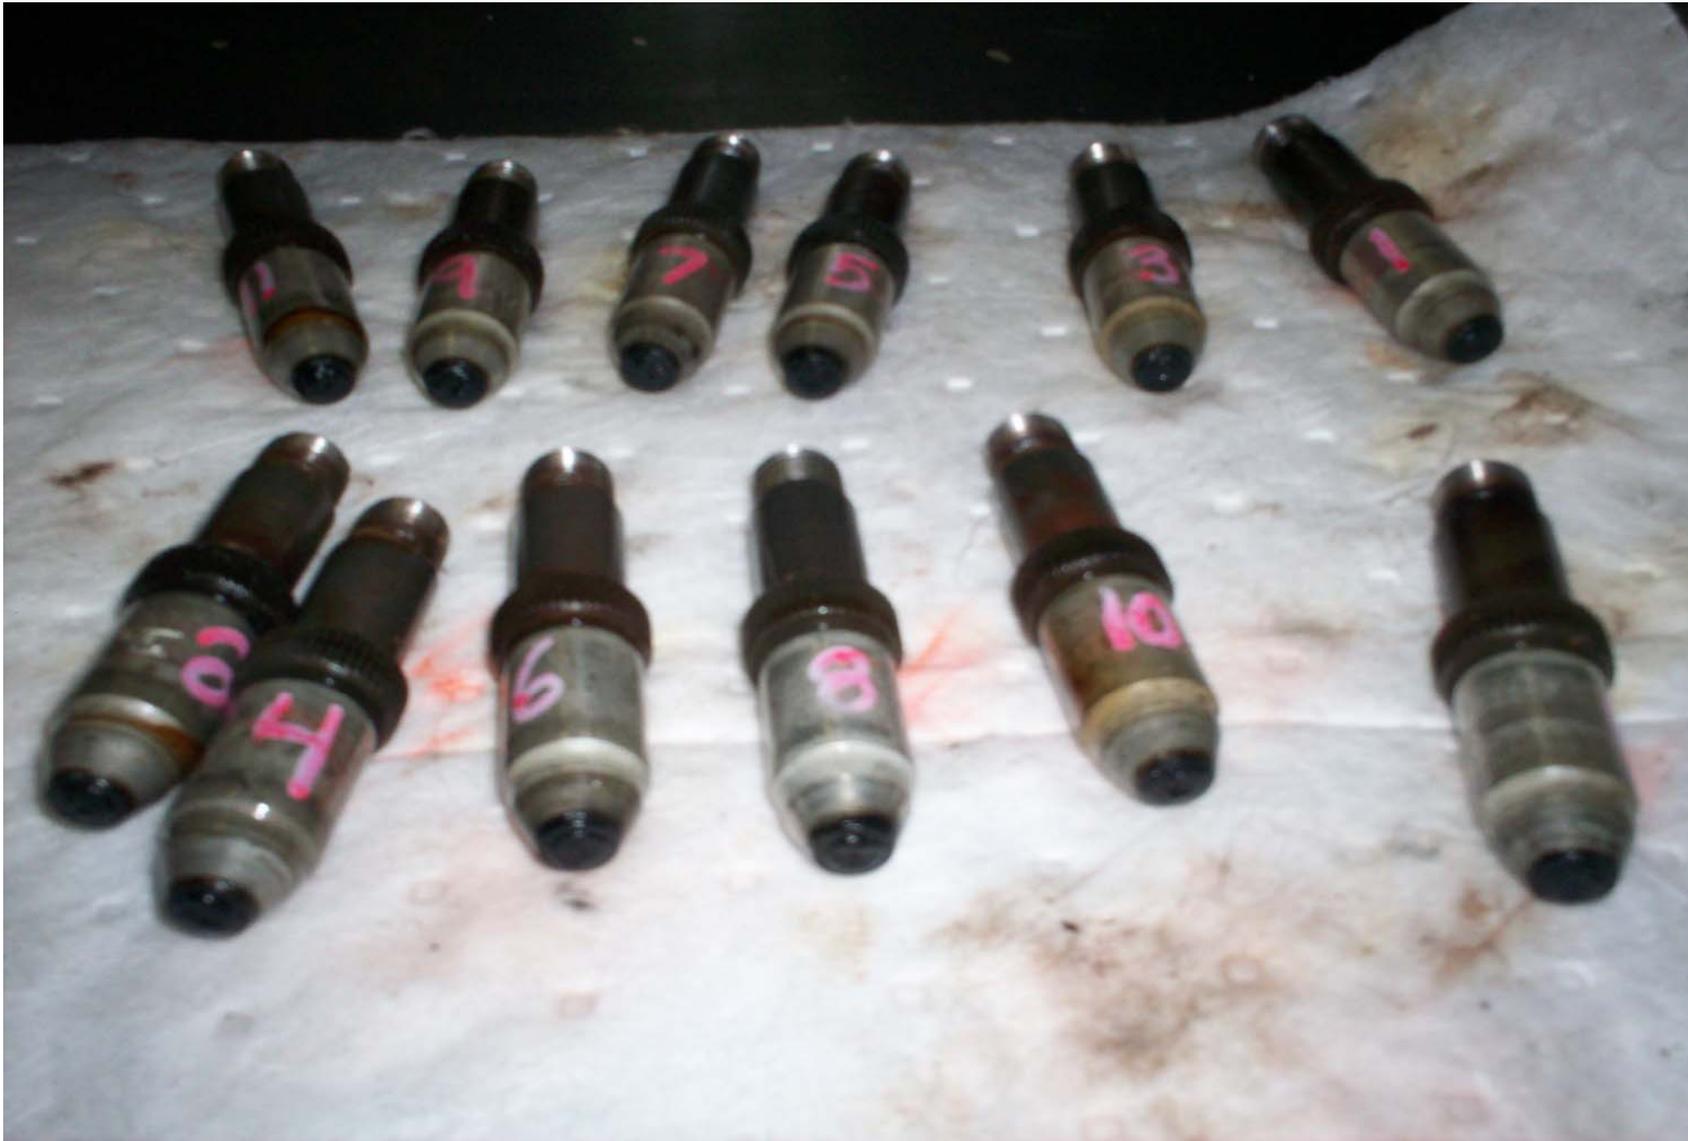
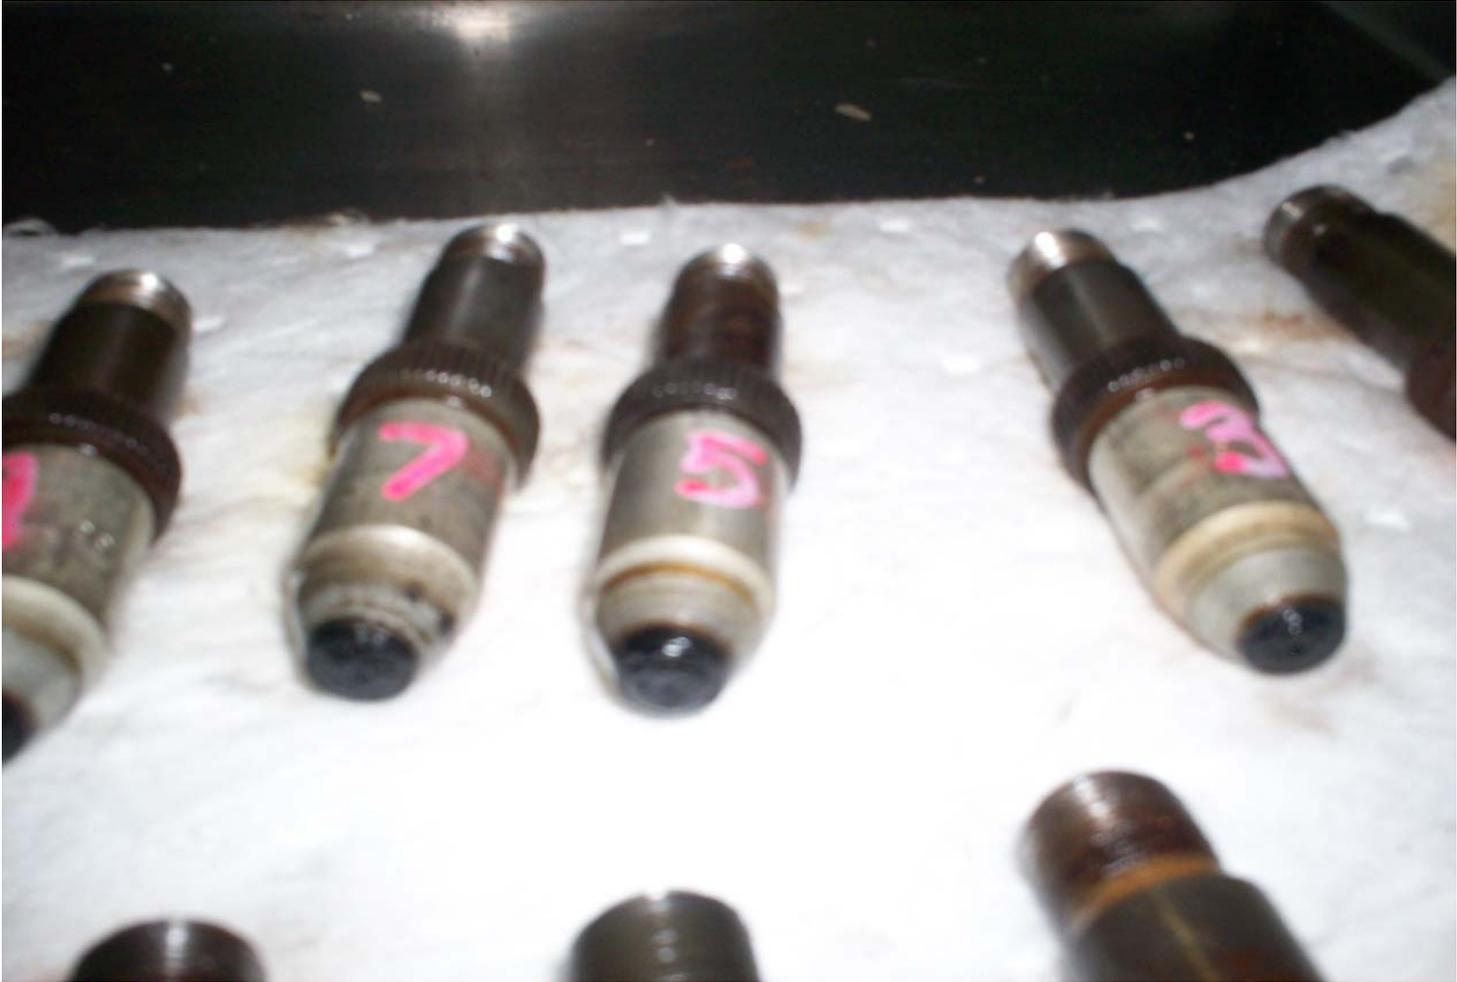
fuel injection nozzle pressure test

Cylinder	Valve opening pressure (psi)	Spray pressure (psi)	Spray pattern	Pressure held for 30 seconds (psi)
1	450	500	good	300
2	450	475	good	300
3	475	500	good	400
4	475	500	good	350
5	475	500	good	350
6	475	500	good	350
7	475	500	good	450
8	525	550	good	400
9	500	525	good	350
10	490	525	good	300
11	480	500	good	300
12	475	500	good	300

Fuel Nozzles - Pre-Test Inspection

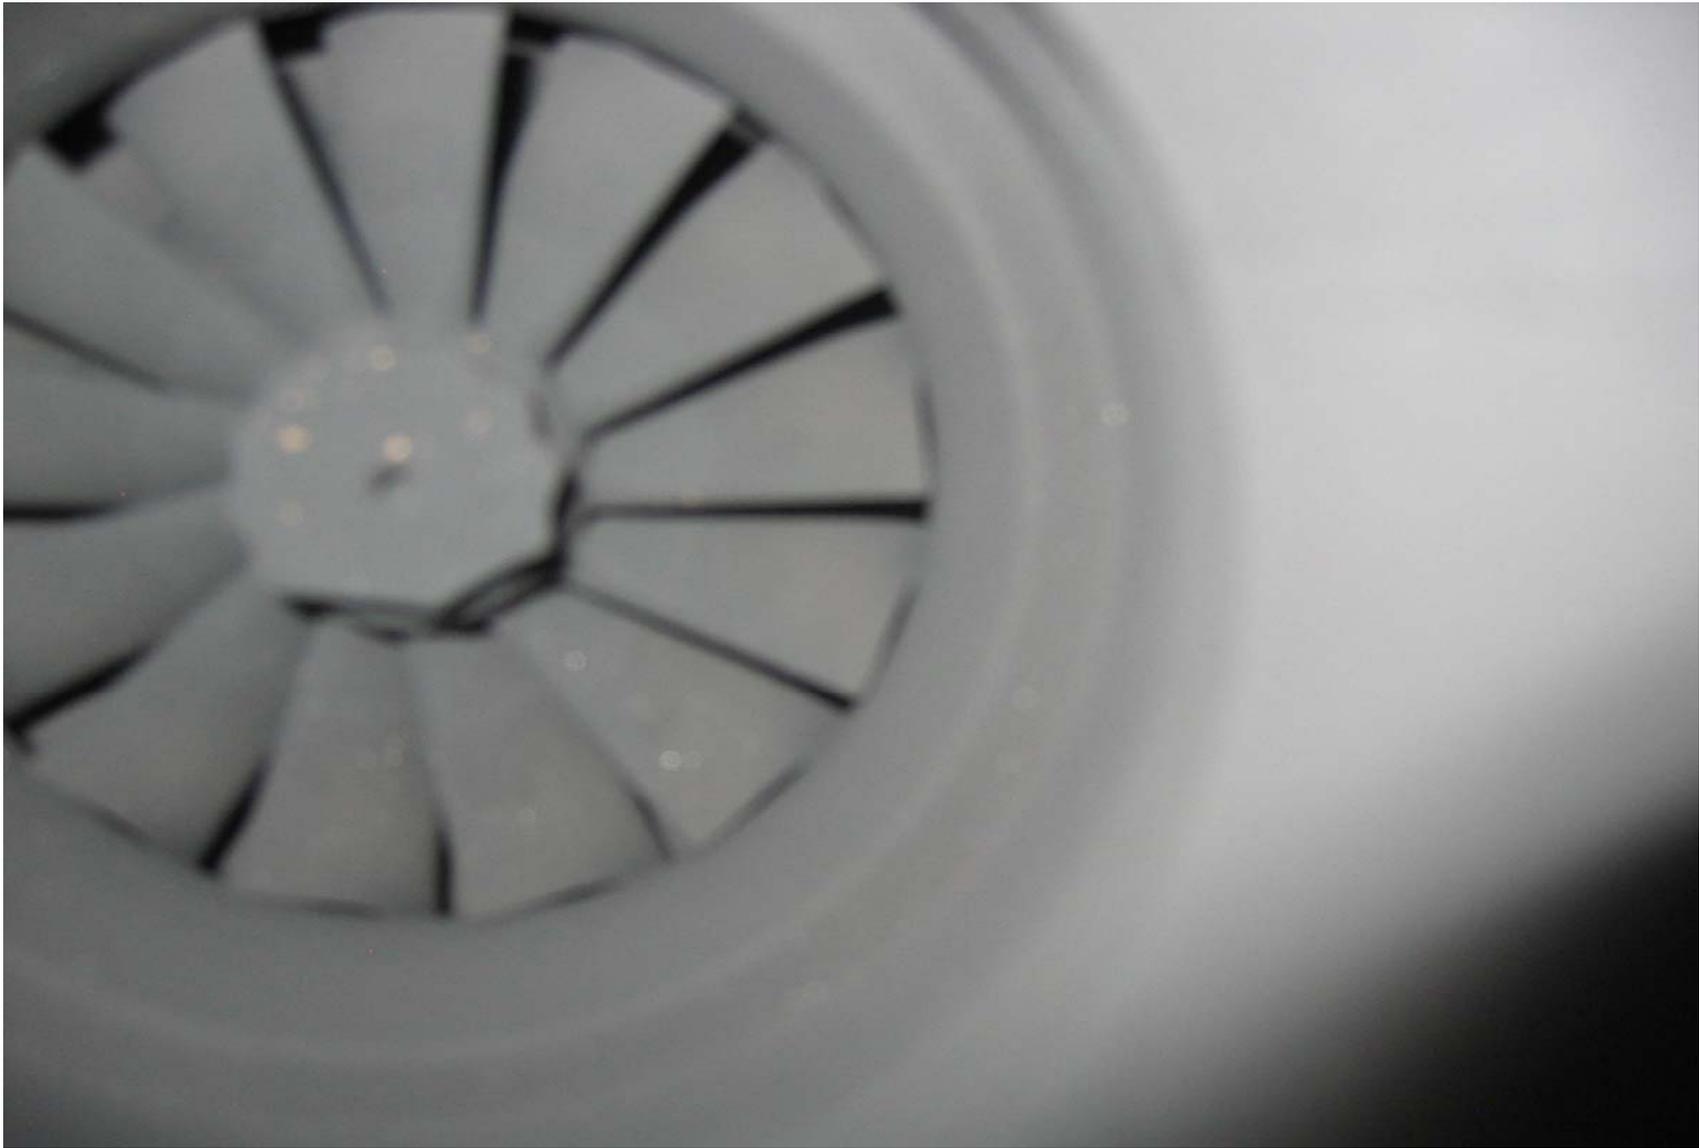
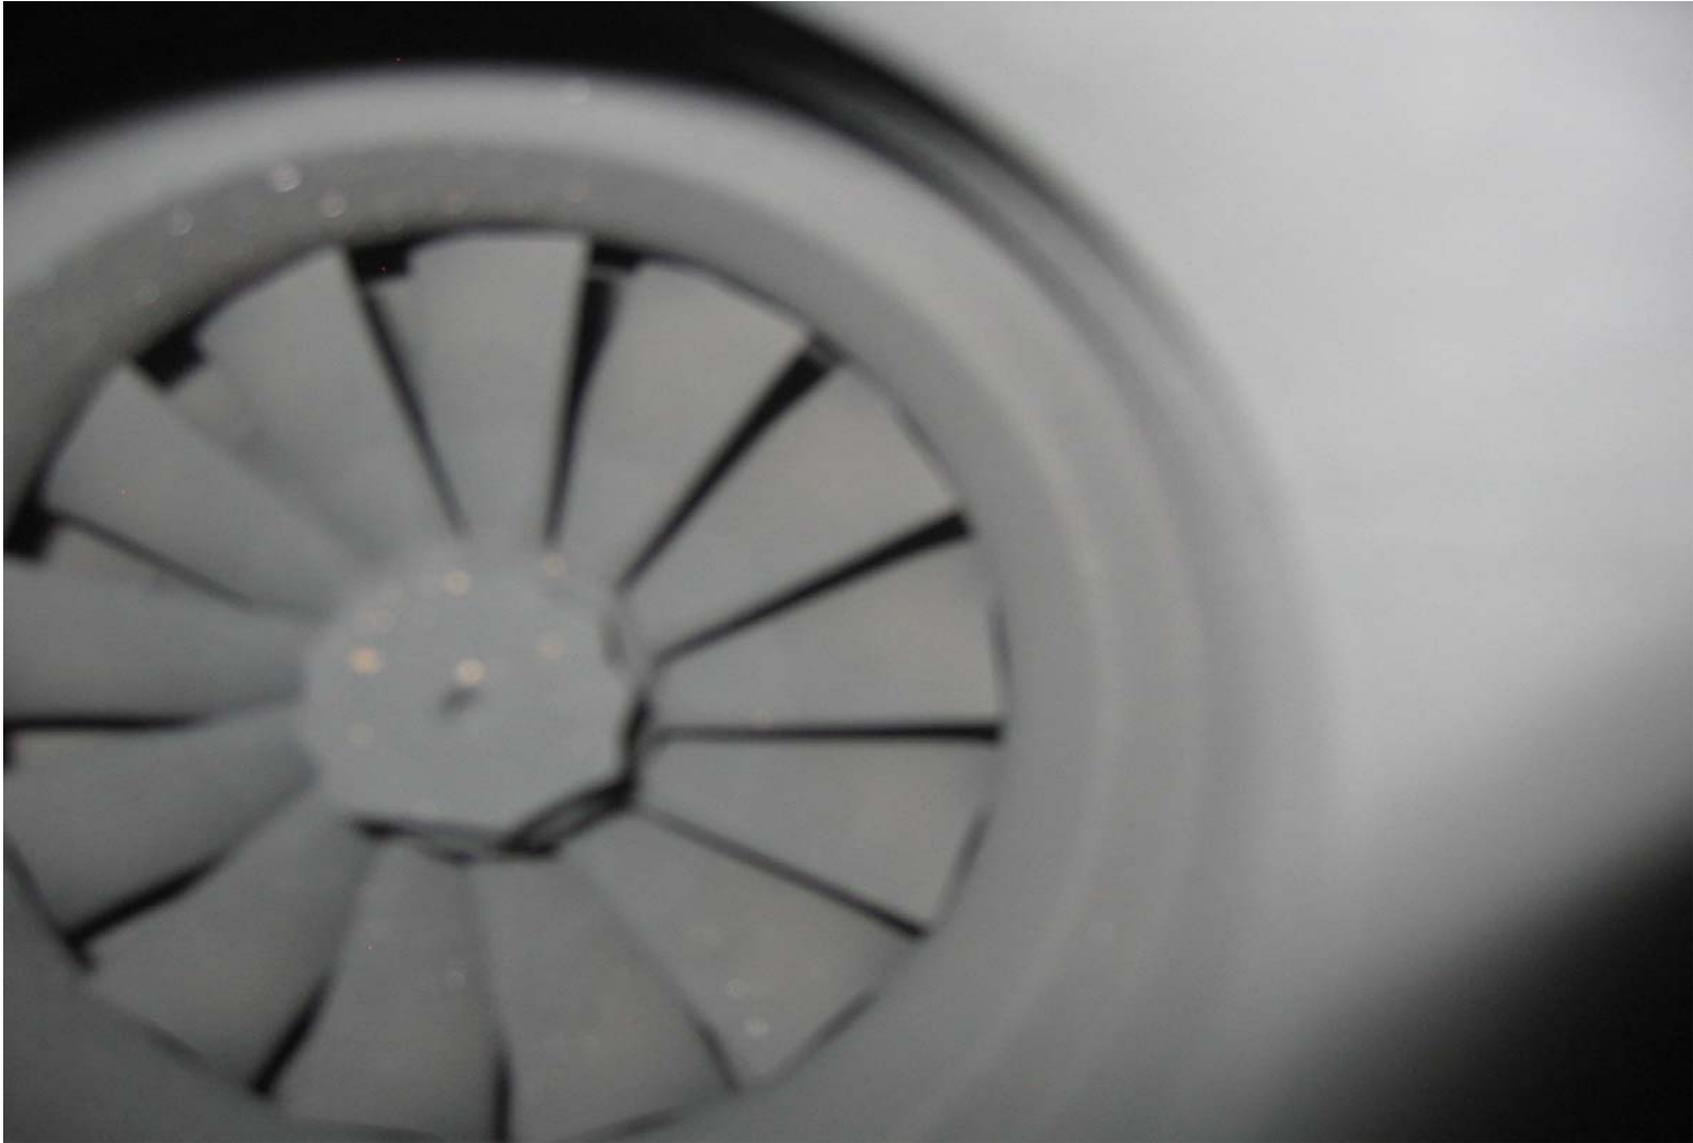
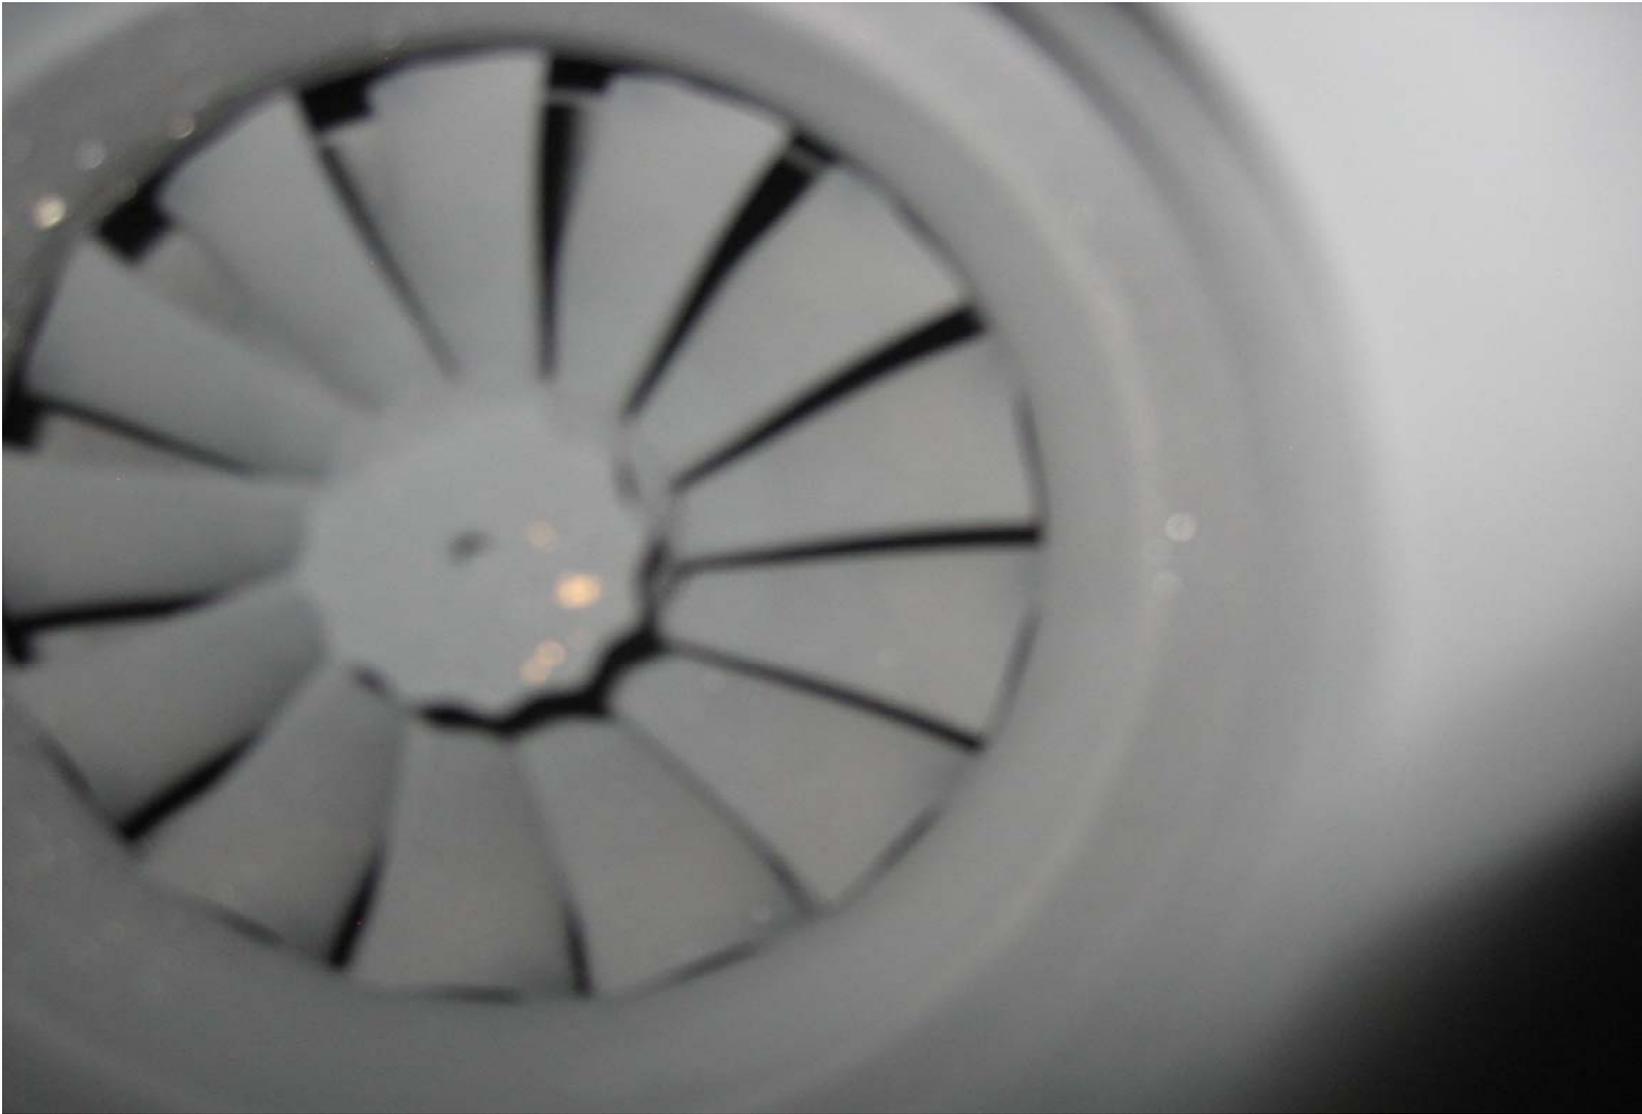
Turbocharger - Pre-Test Inspection
